Type 1 Facility Closeout Report

Facility No. Building B119

Facility Descriptor: WSLLC Fitness Center

Facility No. Trailer T119B
 Facility Descriptor Office Trailer
 Project: RISS
 Date of Demolition: 3/24/04
 Additional Information Attached

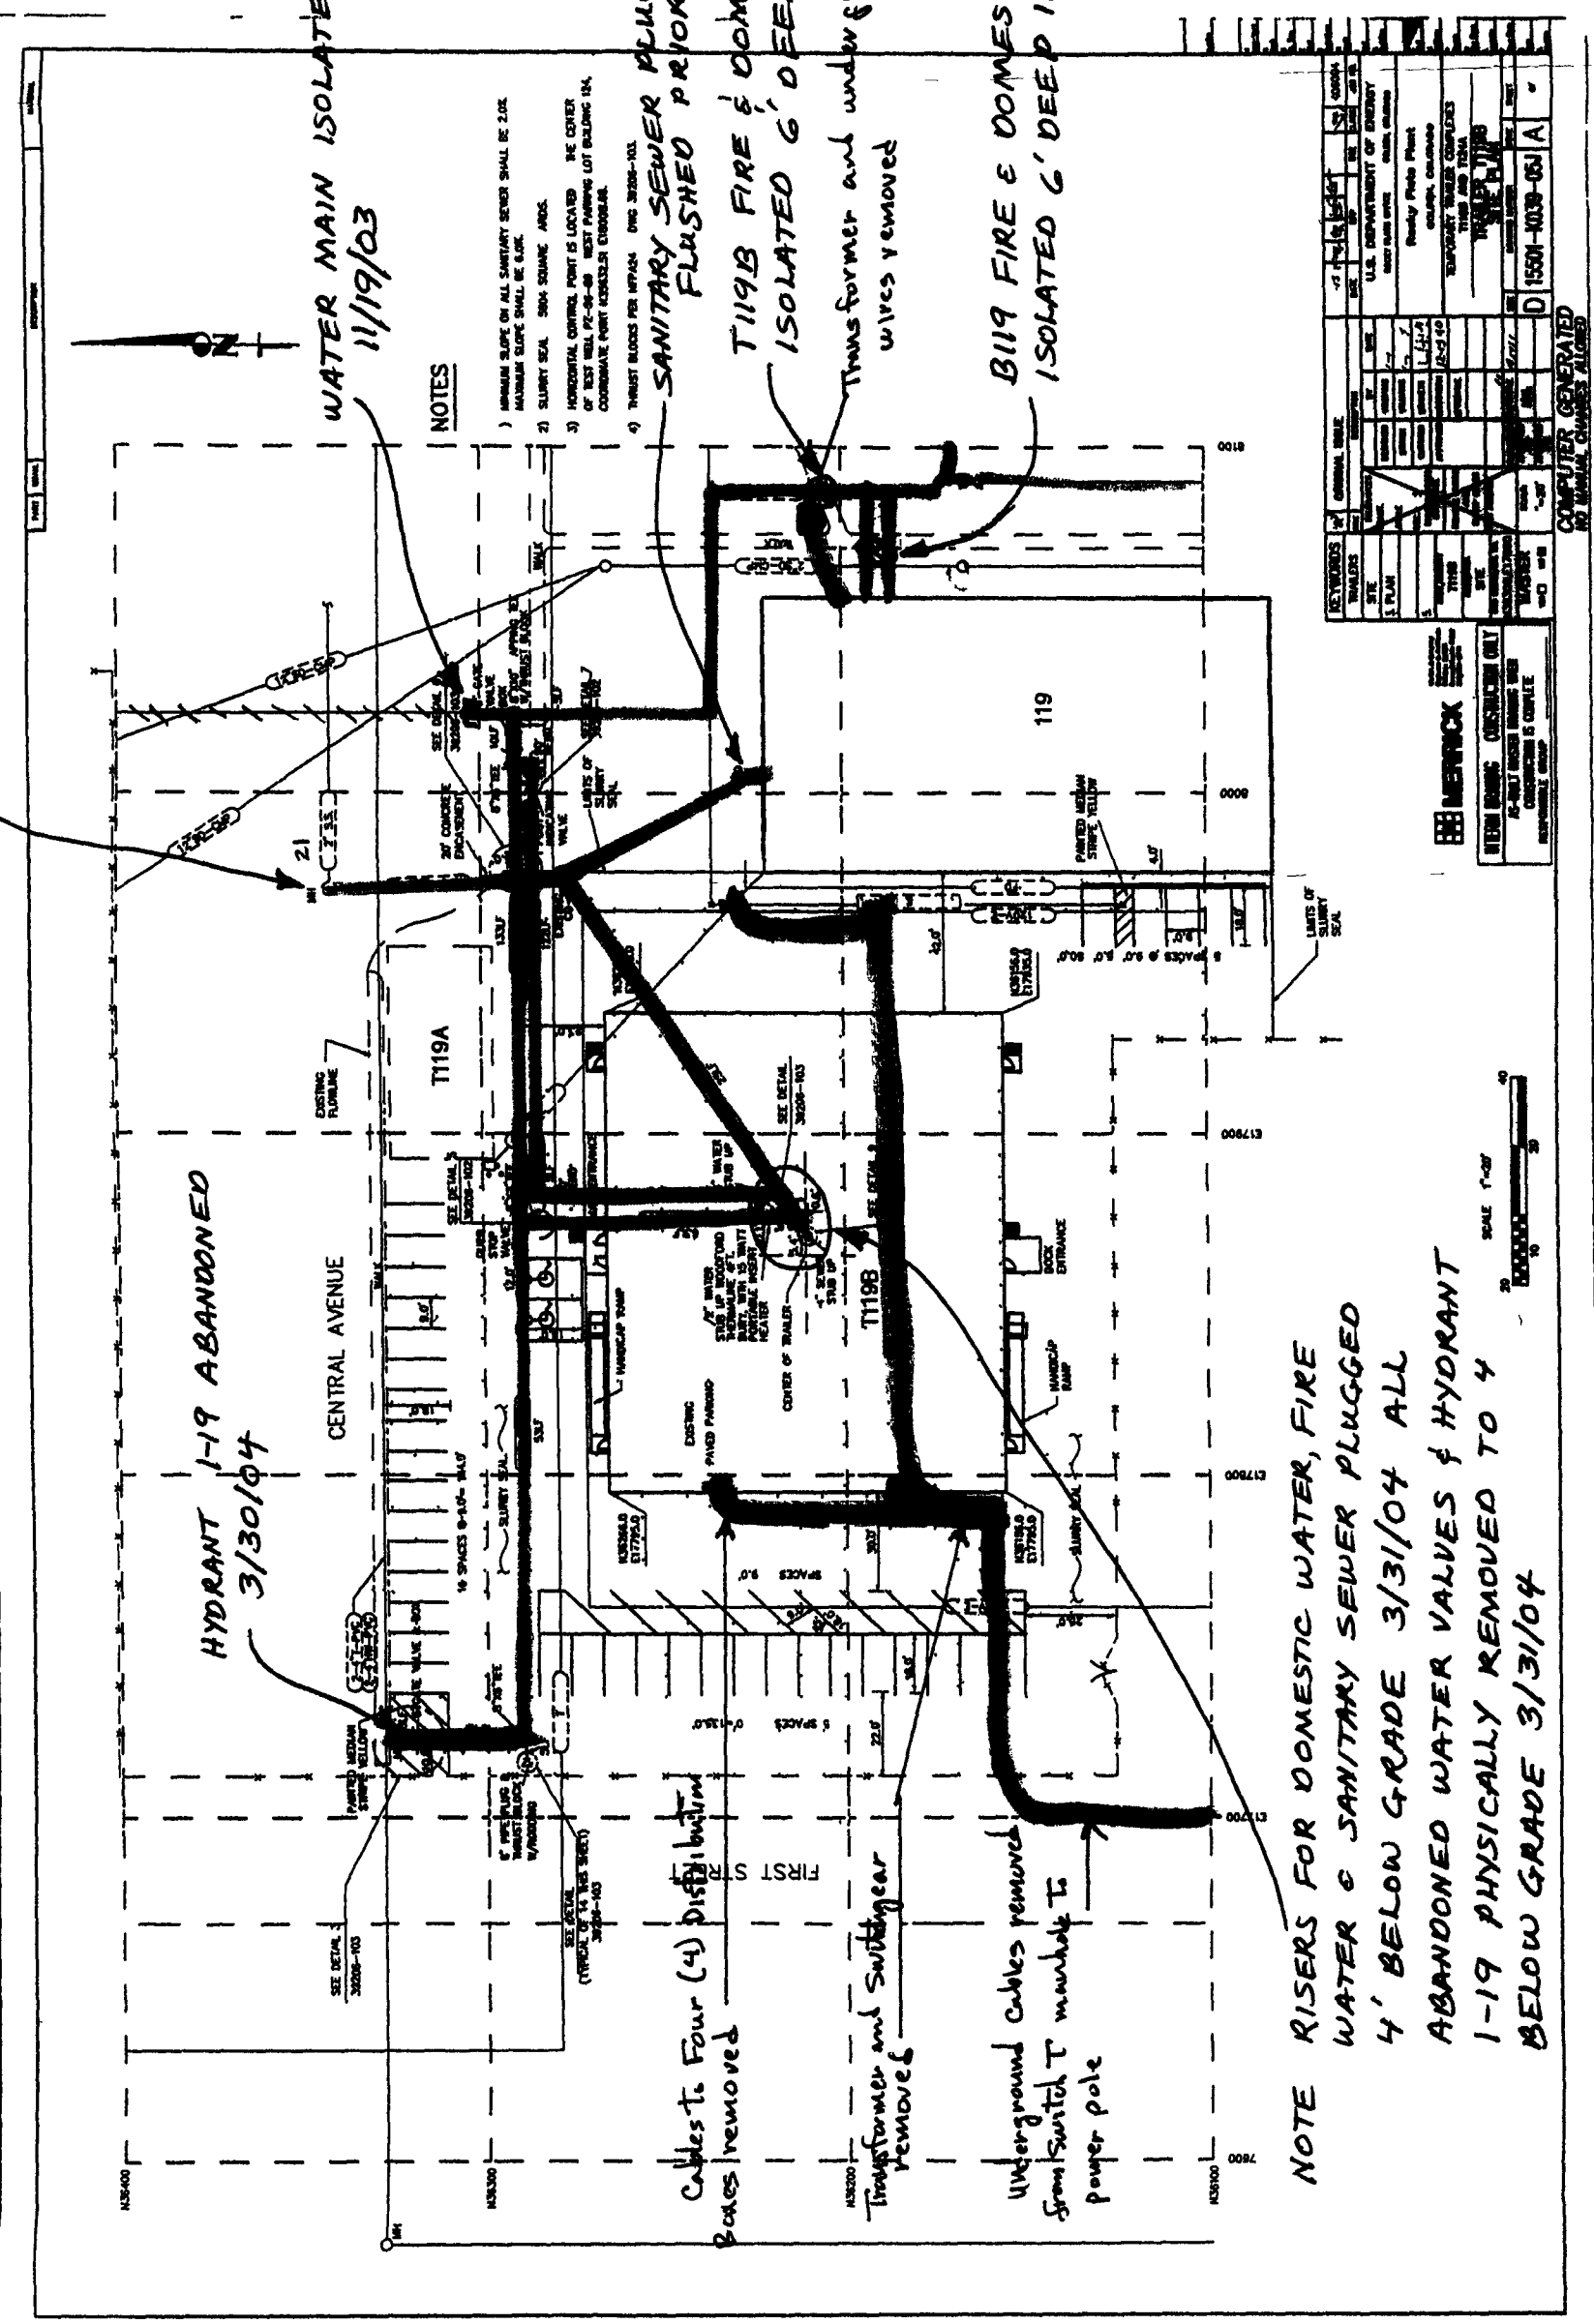
T119B & B119 Utility Disconnections

SANITARY SEWER TO BE PLUGGED AT MANHOLE (SCHEDULE TBD)
